Repair and Rehabilitation of Nehru Memorial College of K.V.G. Group of Institutions at Mangalore - A Case Study

[Paper published in the proceedings of International Conference CEMCON 2011 organised by Indian Concrete Institute, Pune at Pune, India from June 17-18, 2011]

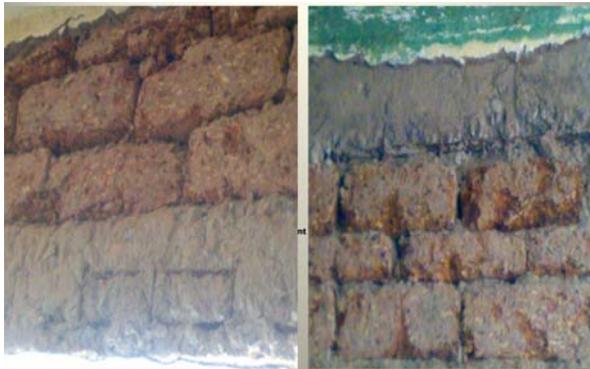
Since the building was very old and located in a marine climate, the water leakages and reinforcement corrosion were major issues. There were leakages in the roof and water seepage through the external walls. The walls were made of laterite stone block masonry. The pointings of the stone masonry were disintegrated and water was leaking through these joints. There were spalling of plaster, cracks in the masonry walls and also cracks in the ceilings of the RCC roof. The water seepages and leakages led to growth of fungus and mosses on the walls and the ceilings. The corrosion of reinforcement led to spalling of concrete. There were cracks in the RCC ceilings and columns.

Spalled plaster, fungus growth in walls

All the external wall plasters were loosened and debonded from the masonry surface for which plastering was chipped out and replastering was done. It was finished with cement mortar admixed with polymer modified mortar and finally protected with an elastomeric acrylic coating.

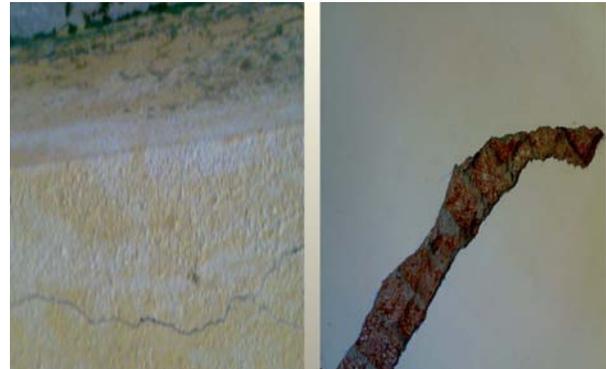
Cracks in the ceiling and masonry wall

There were some cracks in the masonry walls. At those locations the plastering was chipped off and cutting of V-grooves were made along the length of the crack by chiseling. The cleaning was made by a high pressure water jet. A wire mesh was fixed along the cracks after which the cracks were repaired with medium structural grade repair mortar.

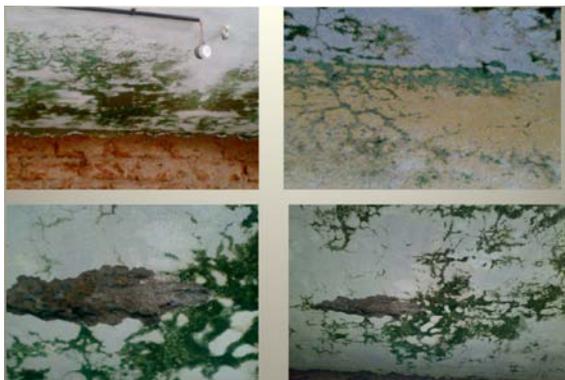
Fungal growth in ceilings

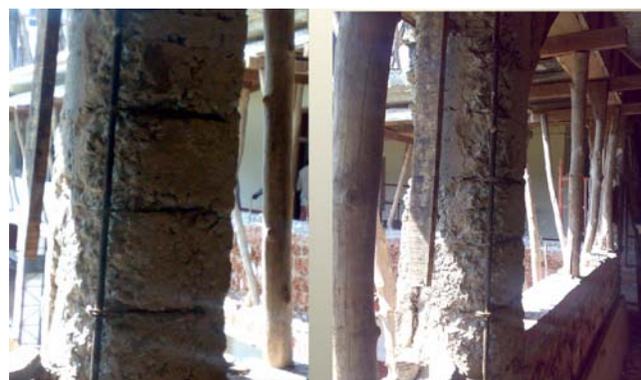
Corrosion and spalling of concrete in columns

The reinforcements in the most of the columns were corroded. There was complete loss of cover concrete in some columns. The following steps were taken:

- Distress and spalled concrete portions were identified and marked for repair and restoration.
- Reinforcements were exposed by chiseling properly with light weight hammer and chisel.

- The exposed reinforcements were properly cleaned by wire brushed and entire concrete and steel surface were washed with potable water.
- Thereafter the reinforcements were applied with a rust remover and rubbed with gunny sacks, wiped properly and washed with high pressure water jet to wash out the traces of any residues.

- Then the same reinforcements were applied with anti-corrosive epoxy zinc primer to prevent further corrosion.
- After that the distressed concrete portions were properly applied with epoxy bonding agent for acting as an impervious layer to restoration patch.

- Finally a cementitious high structural grade repair material was applied in mortar consistency to build the thickness of the cover concrete as needed at site condition.

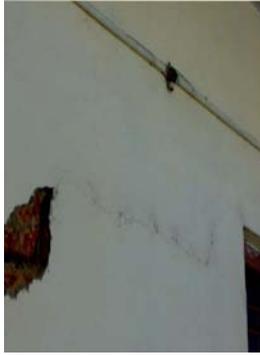
Cracks in walls

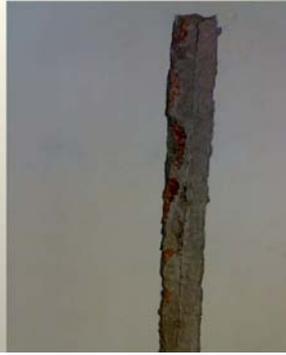
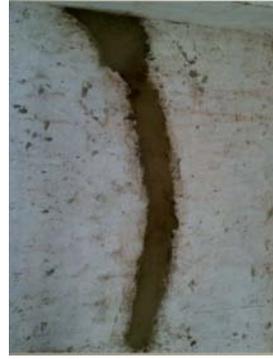
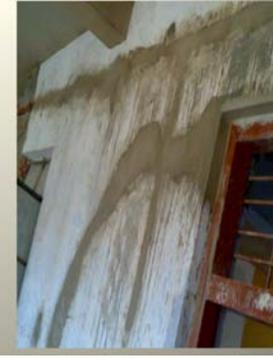
Plastering cracks repaired

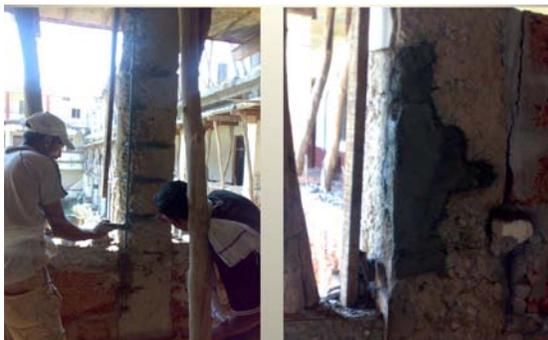
Columns being repaired with structural grade mortar

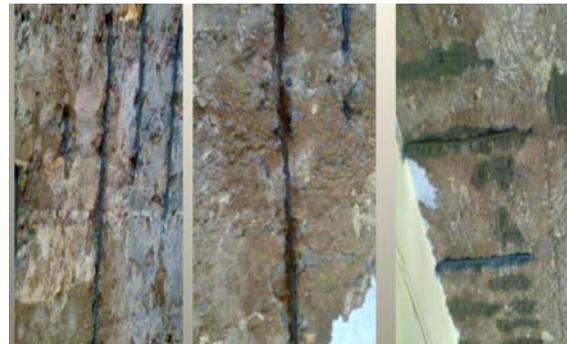
Repairing of ceiling, beam

The ceiling surface of roof slab and beam were also repaired in the similar manner.

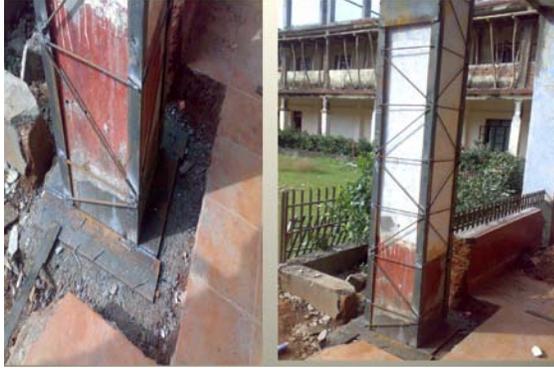
Strengthening of masonry columns by steel jacketing

The masonry columns of the corridor needed to be repaired and strengthened for carrying out additional loads. This was achieved by providing steel jacketing to those masonry columns. The steel jackets were made of 4-ISA 75x75x6 and braced with tie rod in a zigzag way. The concreting was done with cementitious high grade structural repair mortar.

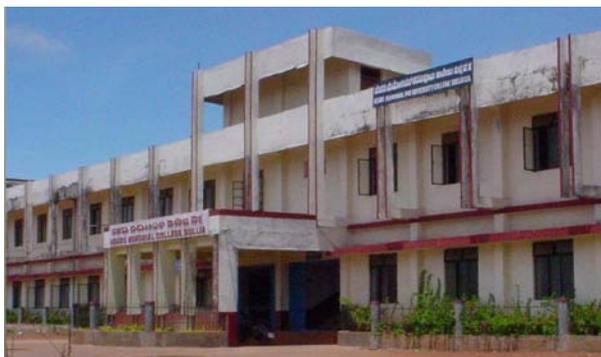
Before repair in distress conditions
