## Corrosion Repair and Protection Measures - A Case Study

[Excerpts from International Journal of 3R's, Vol.2, No.4, pp-337-345]

### 1.0 Background

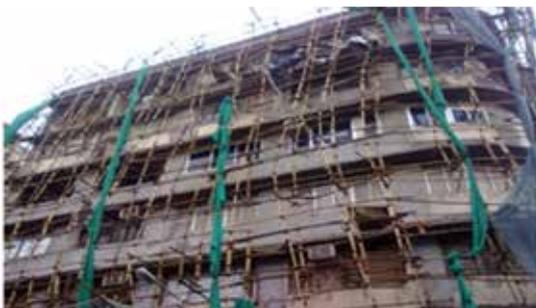
Fig. 1: Continuous sunshade being provided after breaking damaged parties

It was suggested that a continuous sunshade Fig.1 be constructed for protection against rainwater, instead of the old sunshades just over the window openings. This helps prevent water running over empty spaces along the walls that results in the growing of moss and fungus, which causes the appearance of black spots and spoils the paint. All new re-bars were anchored to the beam with the help of FISCHER epoxy resin capsules and 100 mm thick reinforced concrete was cast uniformly with the help of waterproof ply shuttering.

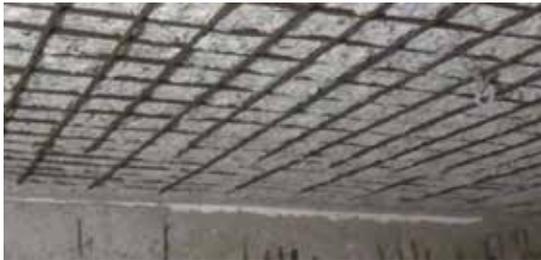
The beams and slabs in the basement were damaged as shown in Fig. 2 due to leakage from the common WC

Fig. 2: View of roof slab before micro concreting

block on the ground floor which were jacketed with micro concrete by drilling a hole from the top floor (Fig. 3).

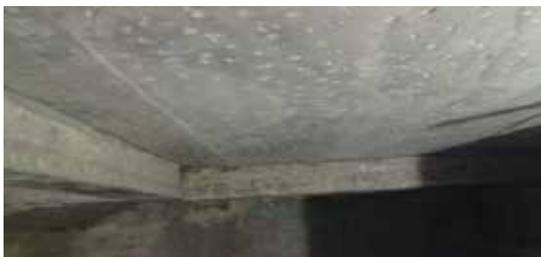
Fig. 3: View of roof slab after micro concreting

A portion of the slab bottom sagged and de-bonded. By providing watertight shuttering, slab casting was done using micro concrete with 6 mm down pea gravels poured from the top floor by making a few core cuttings for maximum flow up to 2 metres (Fig. 3). Similarly the damaged columns were strengthened with micro concreting. Fig. 4 and Fig. 5 show the column before micro concreting and column after micro concreting respectively.

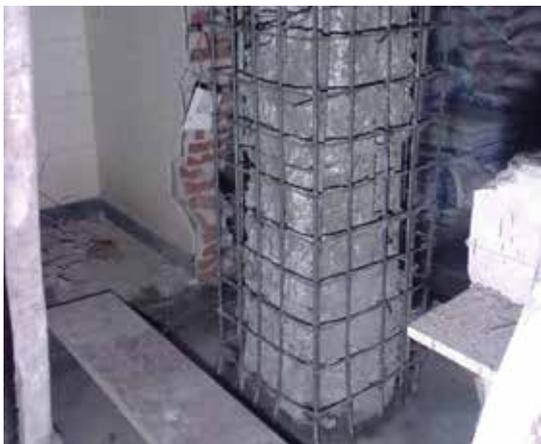
The external columns, beams and slabs on the ground floor and the columns and beams on the top most floors deteriorated very badly and were repaired with a polymer modified mortar and micro concrete. Fibre wrapping on few columns was done to enhance the strength of these weak columns.

Fig. 4: Column before micro concreting

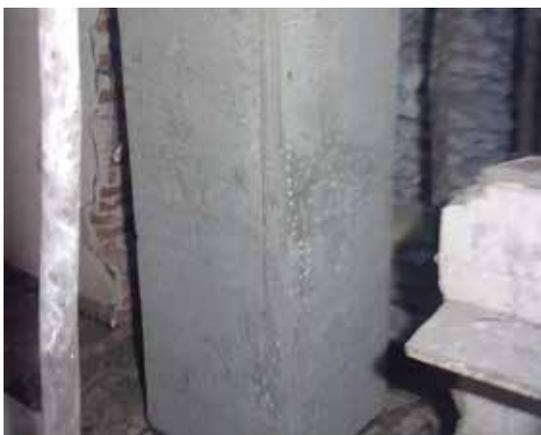
Fig. 5: Column after micro concreting

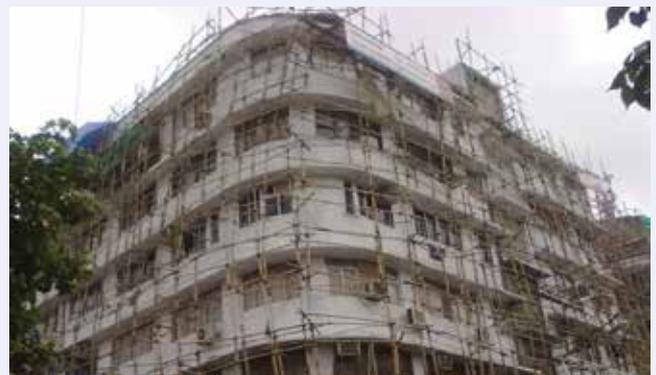
Fig. 6: View after primer coat

The external surface of the building was protected again with good quality coating that had elastomeric properties. A hand roller was used for application instead of a brush. Three coats were applied with the hand roller as per manufacturer recommendations. Acrylic coating was used having crack bridging properties. This is very important for old buildings. A five year warranty against leakage was received and given to the client stating that the manufacturer will give free material during the tenure of the contract and the contractor will apply the material at no extra cost to the Society during the defect liability period. Fig. 6 and Fig. 7 show the external treatment with primer and finished coat respectively.

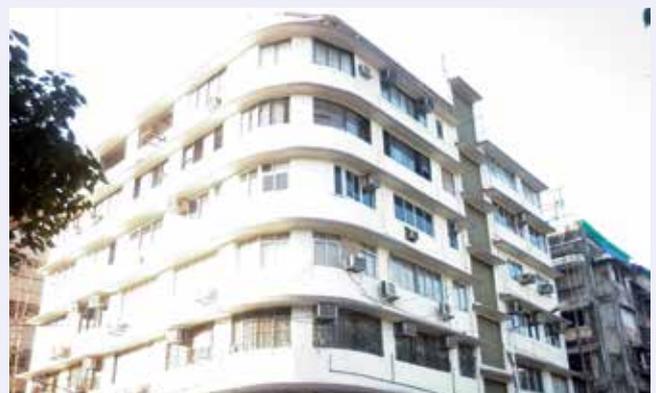
Fig. 7: View after final coating
