## The Importance of Moisture Protection in Preservation and Restoration

## Masonry Repair and Moisture Protection

### A Case study of Russian Church of the Holy Trinity, East New York

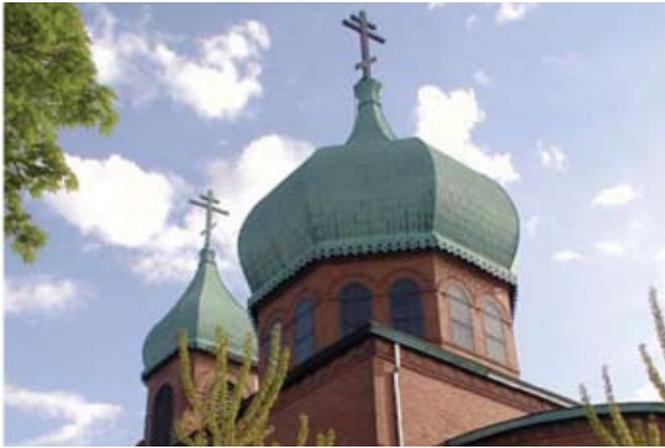
Fig 1: Church of Holy Trinity

Trinity was built in 1935 and located in the East New York section of Brooklyn (Figure 1).

Constructed in a traditional Byzantine style, the masonry structure features large, onion-shaped domes, semi-circular arches, and high arched windows. It features two distinctive domes, the smaller of which functions as a three-story bell tower and houses three massive church bells. At the top of the bell tower, four louvers—one on each of the four sides—enable sound to travel out of the tower.

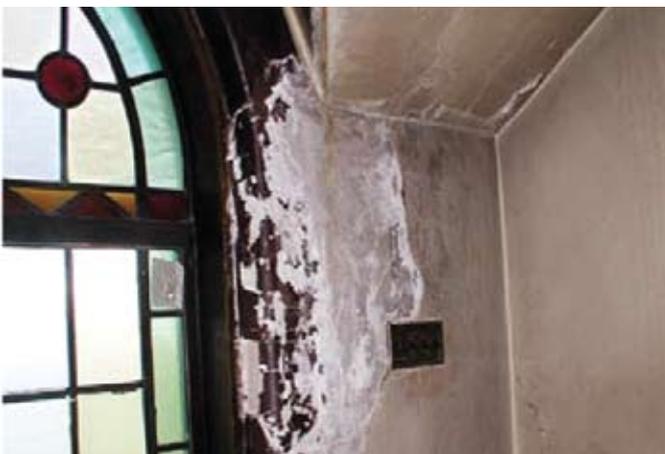
Fig 2: Distress in plastering

Much more of a concern than the cosmetic problems, however, was the fact that the mortar in the brick exterior was beginning to erode and water had begun leaking into the bell tower and the south-east chimney. Water had also begun entering the bell tower's louvers during heavy rains.

Water that made its way into the bell tower would pool on the third level's concrete floor and then seep through to the second level and into the choir area of the church below. The plaster on the ceilings and walls of the church was being destroyed (Figures 2 & 3) by the water damage. But most distressing was the fact that the many historic religious paintings were being damaged and destroyed (Figure 4).

The first step in the process was to remove 68 years of urban grime from the outside of the bell tower and the southeast chimney. A local contractor was hired to power wash all the brick work in these areas using a high-pressure compressor. Then, the original, eroding mortar was removed from around the brick and replaced with new standard brick mortar grout.

Once the brick had been repointed, two coats of a fast-drying water repellent sealer were applied with a sprayer to the exterior vertical surfaces. The church elected to use a sealer containing a blend of silane and siloxane compounds designed specifically for brick, masonry, and concrete that reacts with silicates below the surface of the brick to form an insoluble, water-repellent barrier. Because the finished application is invisible, the original appearance and breathability of the brick are maintained. The sealer is designed to not fade, yellow, crack, peel, or wear away.
