Case Studies of Remedial Waterproofing

5.0 Remedial Terrace Waterproofing of Dabur India Limited at Ghaziabad with Polymer Modified Bituminous Coating

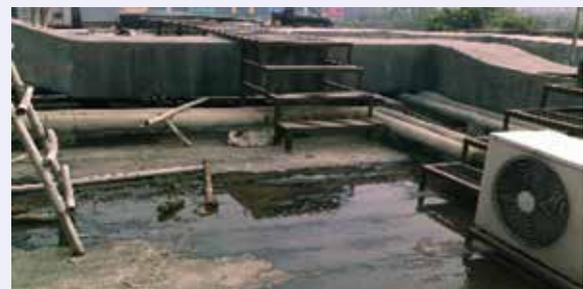
Fig. 1: Intrusions on terraces

Mostly production plants have different assemblies or intrusion on their roof terrace. The same case was also with Dabur Ghaziabad plant. There were many intrusions (Fig. 1), cables, pipes and ducting (Fig. 2) as well as less floor clearance on the terrace. Usually, pre-fabricated

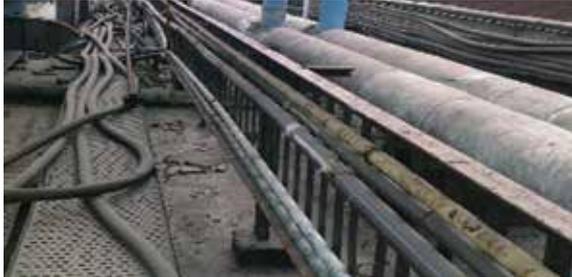
Fig. 2: Cables, ducting & pipes on terraces

membrane is not recommended for waterproofing in such conditions, since intrusions make hindrance in placing the membrane and less clearance makes working very difficult. Due to the limitation of pre-fabricated membrane, it was recommended for polymer modified bituminous emulsion liquid applied waterproofing coating.

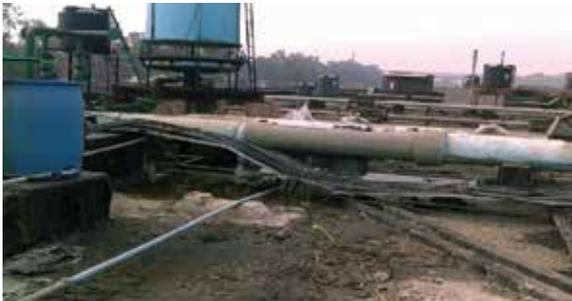
Fig. 3: Damaged existing tar layer

There were many areas in the terrace where the existing waterproofing layer had torn out (Fig. 3). The cooling tower area over the administrative block was one of the worst damaged areas where even existing treatment was torn out badly.

Before application of any other waterproofing coating in this scenario, one is required to take out existing waterproofing layer totally till the mother slab. In this case, the damaged tar layer was removed manually (Fig. 4).

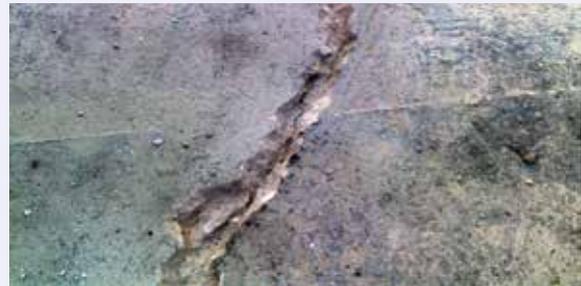
Fig. 5: Wider cracks on parent slab

This would ensure the proper bonding of new coating with the parent slab. After removal of the tar layer, the minor hairline cracks and wider cracks (Fig. 5) at some location were seen on the mother slab. Unsound patches and cracks

on the parent slab must be treated properly for good performance of any coating. In this case, there were many cracks and unsound patches which were treated well with polymeric crack filling material and SBR based polymer modified mortar before priming the surface.

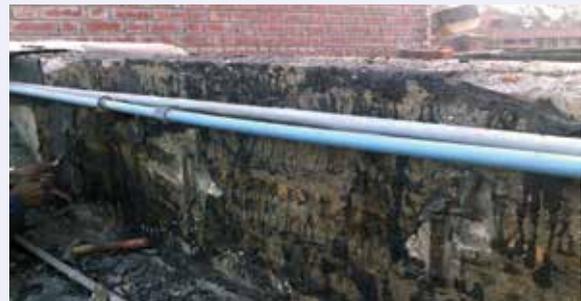
Fig. 6: Tar felting layer chipping off from parapet wall

All the tar felting layers from the parapet wall were also chipped off (Fig. 6). In case of parapet walls, where plaster was badly damaged, re-plastering was required. The mortar used for re-plastering contained an integral waterproofing admixture. On the finished plaster, a waterproofing coating was applied. Watta (Fig. 7) of same cement mortar was prepared and placed at the junction of roof and parapet wall and other places wherever required.

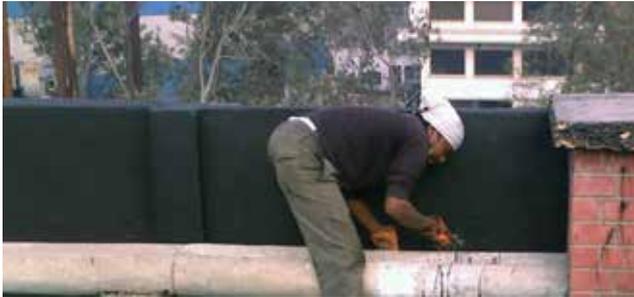
Fig. 8: Application of primer in progress

done for proper bonding between the substrate and the coating (Fig. 8). In this case, a bituminous based primer was chosen as primer since the recommended coating was bituminous emulsion, and the primer was allowed to be dried completely.

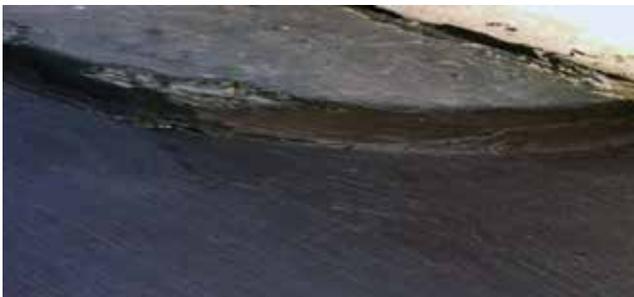
Fig. 9: First layer of bituminous coating

The first coat was applied with a brush (Fig. 9) and allowed to be dried completely over which fibre mesh (Fig. 10) - as reinforcement of coating - was sandwiched between first and second layers of elastomeric bituminous coating after which another two layers were applied. Altogether, it provided a thick layer of coating on the surface (Fig. 11).

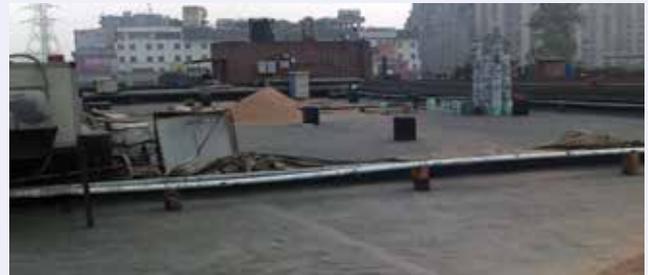
Fig. 12: Screeding being done

Screed on final layer of waterproofing coating is a good practice to avoid any damage due to foot traffic and enhance the performance of the coating. It also ensures proper slope of the surface. In this case, a screeding was done with M20 grade of concrete with proper slope by using an integral water proofing additive in the mix (Fig. 12). Slope of screed was between 1 in 100, with at least 50 mm thickness at the drain outlet. Screed was cured and dried completely and the roof was allowed for foot traffic.
