## Membrane Integrity Testing & Electronic Leak Detection by Vector Mapping and Case Studies

### 1.0 Introduction

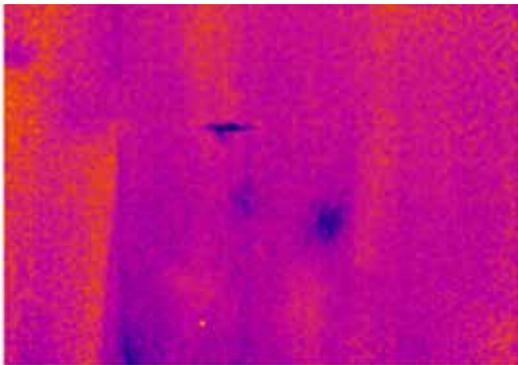
Fig. 15 indicates the location of the water within the wall as it moves behind the wall, surfacing at the top and bottom of the window. At this point of the test water was dripping from the window header on to the floor of the living room. Water testing continued with the spray rack positions at different locations. As the rack moved away from the valley of the roof the water intrusion decreased, finally stopping with the completion of the water testing.

Fig. 15: Thermogram showing the beginnings of the water intrusion

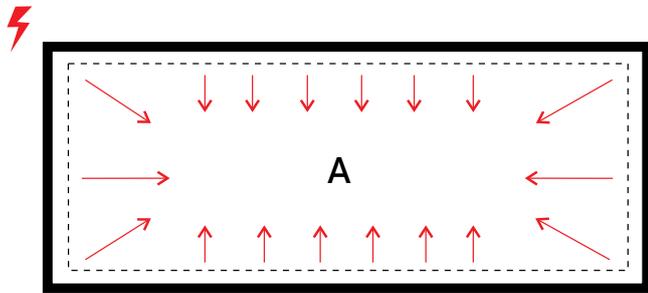
**A:** Small electrical pulses are directed onto the membrane. The electricity searches for a ground connection

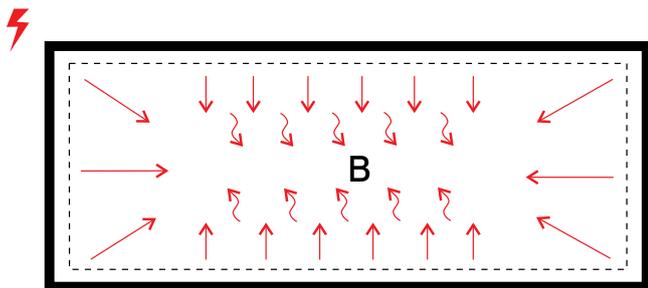
**B:** If the membrane is watertight, the electricity is isolated and does not find a ground connection

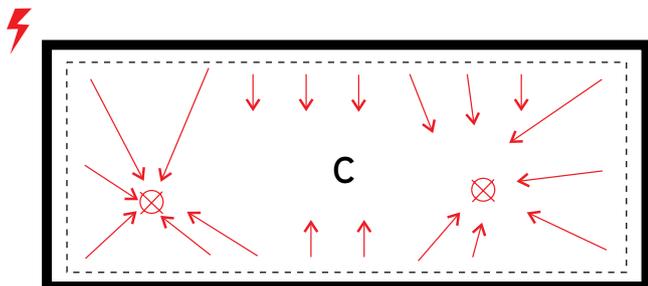
**C:** If the membrane is not watertight, the electricity makes a ground connection and is pulled toward positive poles.

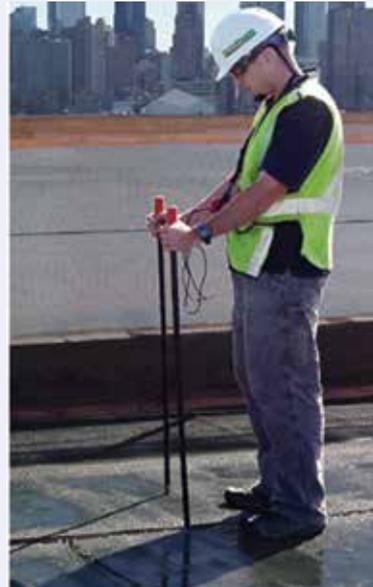
In low voltage vector mapping (Fig. 1), the surface of the roof membrane is moistened (not flooded) to create an electrically conductive medium.

A conductive wire loop is laid out on the membrane around a section of the area to be tested. One lead from a pulse generator is connected to this wire perimeter. The other lead from the generator is connected to a ground, either the structural deck or a GroundScreen™ conductive mesh installed in the system. Leaks or breaches in the membrane are detected when the electric current flows across the moistened membrane and through the breach to the deck, completing the circuit. The technician uses two probes connected to a receiver to determine the direction of the current flow and to precisely locate the breach (Fig. 1).

**Fig. 1:** In Low Voltage Vector Mapping (wet testing) the technician uses metal probes on a wet surface to pinpoint membrane breaches

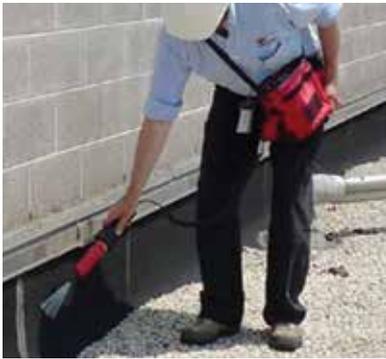
Unlike the low voltage method, high voltage testing is performed on a dry horizontal or vertical surface using a very small current at a relatively high voltage for safe and reliable testing (Fig. 2).

**Fig. 2:** High Voltage ELD (dry testing) is ideal for testing flashings and other vertical surfaces

One lead from the portable current generator (charger) is grounded to the conductive roof deck (either metal or concrete) or a GroundScreen™. The other lead is attached to a special electrode brush made with highly conductive metal bristles. As the technician “sweeps” the brush electrode over the surface of the roof membrane, electricity will flow through any breach in the membrane.

This completes the circuit between the brush and the ground, and immediately pinpoints the location of the fault. Where there are no breaches, the membrane acts as an insulator and prevents the flow of current to the deck.

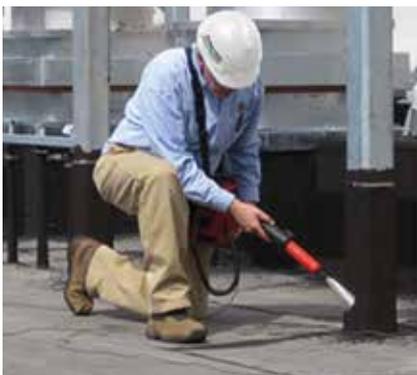
ELD Fusion combines traditional Low Voltage Vector Mapping (wet testing) on large horizontal areas with High Voltage ELD (dry testing) on vertical surfaces, transitions, and other areas not tested with the low voltage technique (Fig. 3). ELD Fusion gives 100% coverage, and a 100% efficient leak free test.

**Fig. 3:** ELD Fusion method of membrane integrity testing

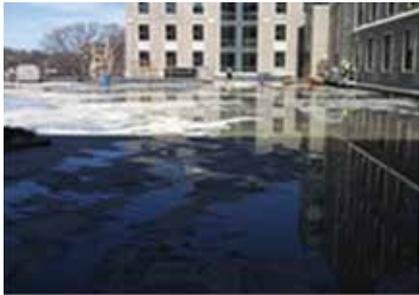
Fig. 4: EVFM and flood testing for watertightness

Once the waterproofing was completed, a 48-hour flood test was performed and the area was deemed watertight. A testing agency was called in immediately after the flood test in March 2011 to complete the EFVM testing (Fig. 4). After the EFVM test, over 50 breaches (Fig. 5 & 6) were located within the membrane, which were found to be mainly due to mechanical damage. Unlike a flood test that only shows a membrane's ability to hold water, the EFVM test is a pinpoint-accurate test that confirms watertightness, or, in this case, a test that located potential active leaks.

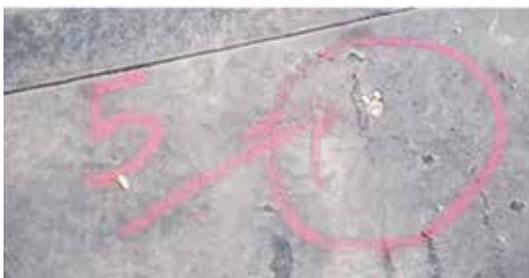
Fig. 6: Breach no 5 as detected by EFVM test

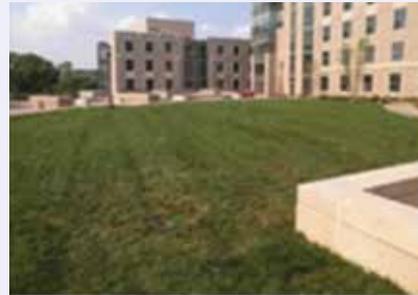
EFVM testing gives an exact location, making repairs simple and quick without any additional inspections required from the contractor. A report was issued to the roofing contractor listing all breach locations and a plan drawing as well for reference. Once all repairs had been made and retested, all of the overburden was put in place and the plaza deck was completed (Fig. 7).

Fig. 7: View of plazadeck after the repair with overburden

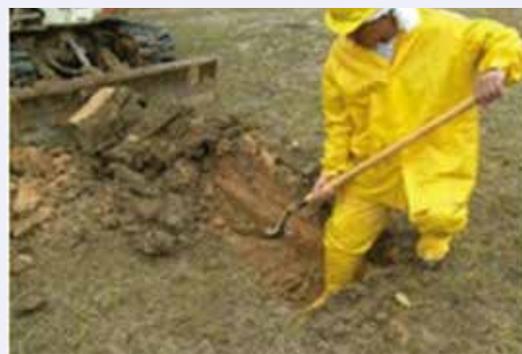
Fig. 8: Pinpointing the leakage location and further removal of overburden for remedial treatment

Since the vector wire was not installed prior to the dumping of soil, the technician had to weave a temporary wire through the soil around the lid area. Because the soil acted as a conductor, the EFVM test could be conducted and the readings obtained were strong. The technician was able to locate multiple breaches. Once a breach was located, the technician placed numbered landscape flags to allow for excavation of the soil (Fig. 8) and subsequent sheet membrane repair. The contractor made the repairs (Fig. 9) and the areas were retested

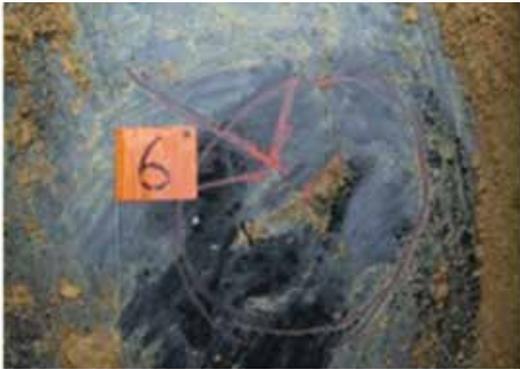
Fig. 9: Remedial waterproofing at leakage point

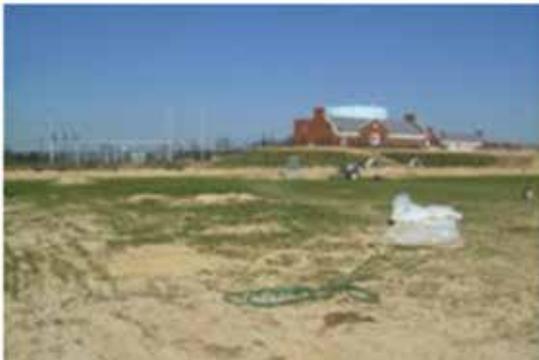
to confirm watertightness. Since the completion of the test, the fresh water tank has remained free from ground water contamination. A view of overburden after repair and installation of waterproofing system is shown in Fig. 10.

Fig. 10: View of overburden after repair and installation of waterproofing system

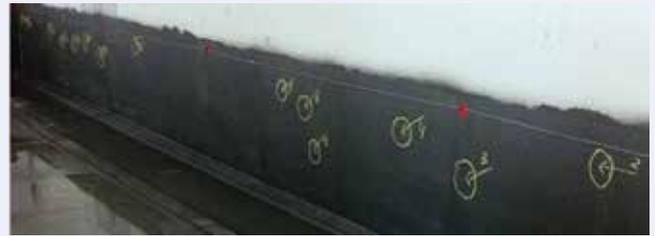
To verify the installation of both horizontal and vertical applications, a testing agency was retained to conduct an EFVM test to ensure a watertight installation. Beginning in late June 2011, began testing the newly-installed waterproofing membrane. The membrane appeared to be intact and watertight, but EFVM testing found areas of damage (Fig. 11) that were not visible to the naked eye. Until the advent of EFVM technology in the mid 1990's, there was never a successful testing method for the verification

Fig. 11: Breaches identified by vector mapping test on vertical surfaces of the membrane

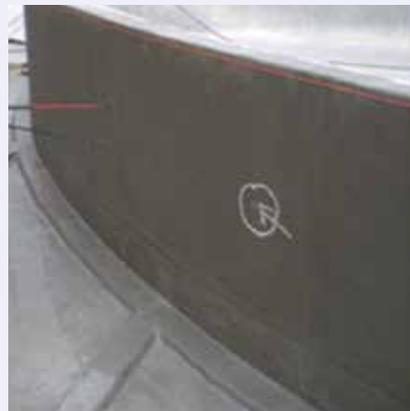
of vertical waterproofing installations. With millions of square footage of vertical waterproofing being installed every year, a method of vertical testing was conducted and accordingly remedial waterproofing (Fig. 12) was made.

Fig. 12: Remedial waterproofing at leakage point
