Self-levelling Epoxy Flooring - Case Studies

[Excerpts from Dr. Fixit Case Studies]

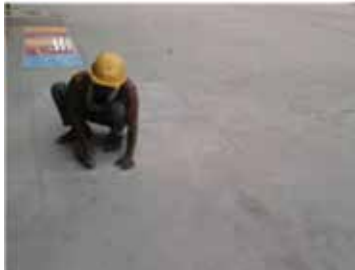
Fig. 1: Inspection of condition of floor

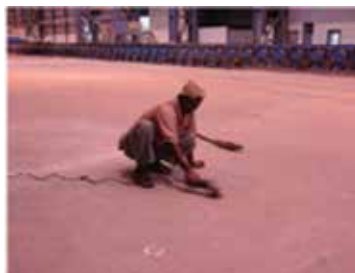
Fig. 2: Floor grinding

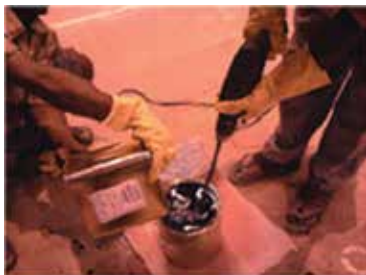
Fig. 3: Mixing of two component primer Dr. Fixit Pidipoxy EP

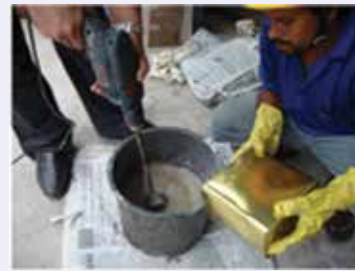
Fig. 5: Mixing of Dr. Fixit Pidipoxy Underlay-SL

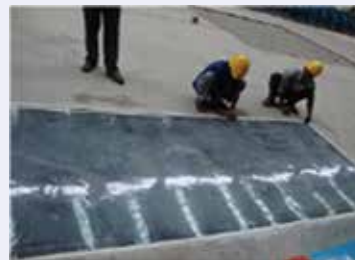
Fig. 6: Application of Dr. Fixit Pidipoxy Underlay-SL

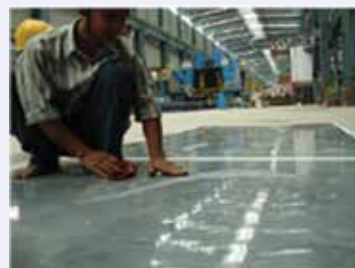
Fig. 7: Application of Dr. Fixit Pidipoxy Underlay-SL

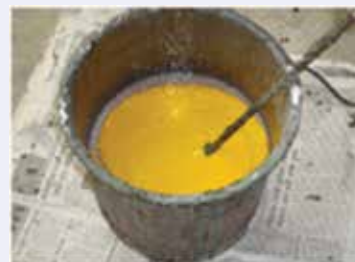
Fig. 8: Mixing of Dr. Fixit Pidipoxy ESL 1000

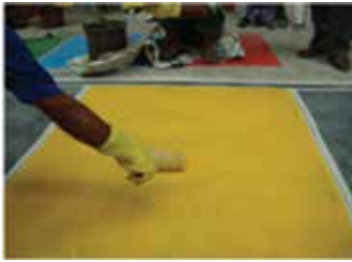
Fig. 9: Application of finished coat with Dr. Fixit Pidipoxy ESL 1000

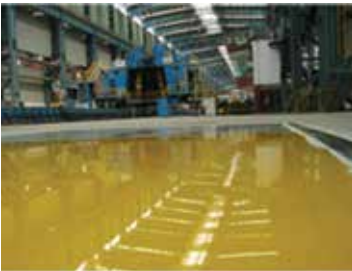
Fig. 10: View of self levelling epoxy industrial flooring after installation

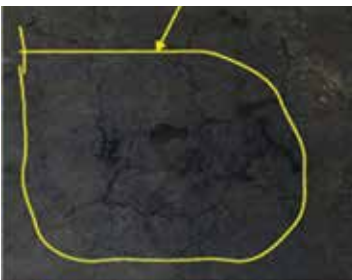
The floor surface of workshop of comprehensive vehicle unit of EME Shillong, Meghalaya (Fig. 11) had many cracks, oil spillage and deteriorated concrete floor at their repair bay, tool stores, spare stores and machine room (Figs. 12-13). The existing concrete floor was needed to be replaced with seamless, tough and an aesthetic look floor finished modern flooring. Epoxy self-levelling flooring from Dr. Fixit was used to replace the existing concrete floor and flooring was successfully completed, thereafter same specification was recommended for flooring in all their workshops of EME.

Fig. 12: Cracks in existing floor

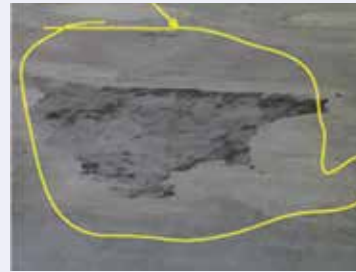
Fig. 13: Debonding of floor surfaces due to wear and tear

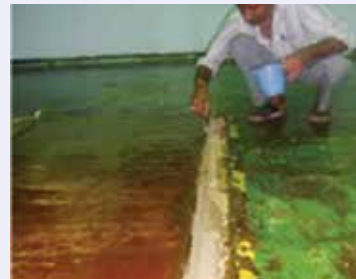
Fig. 14: Sealing moving joints for floor with Dr. Fixit Pidiseal 43

The unit repair bay, Tools and stores, Spares Stores and machine rooms were applied with Dr. Fixit Pidiseal 43 for treating concrete joints (Fig. 14), Dr. Fixit Pidipoxy EP as primer, Dr. Fixit Pidipoxy ESL 1000 Epoxy flooring system as finished coat and Dr. Fixit Pidipoxy EC SF for borders and drawers.

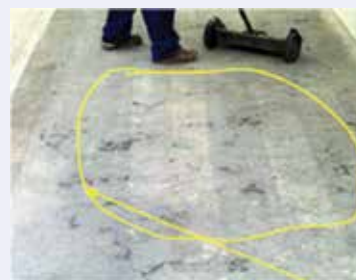
Fig. 15: Scraping of concrete surface and exposing weak floor concrete substrate

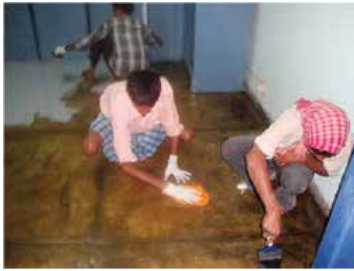
Fig. 16: Priming of floor surface

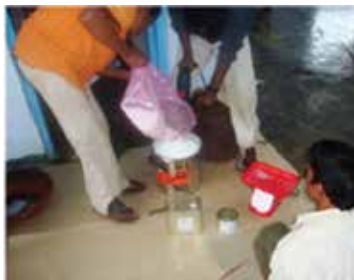
Fig. 17: Mixing of primer Dr. Fixit Pidipoxy EP

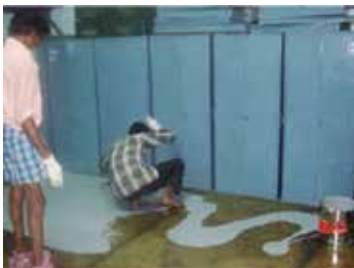
Fig. 18: Application of Dr. Fixit Pidipoxy EP

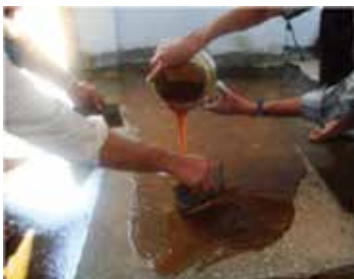
Fig. 19: Mixing of Dr. Fixit Pidipoxy ESL 1000

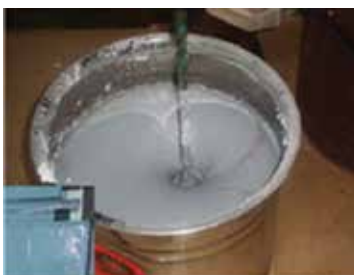
Fig. 20: Mechanical Mixing in a container

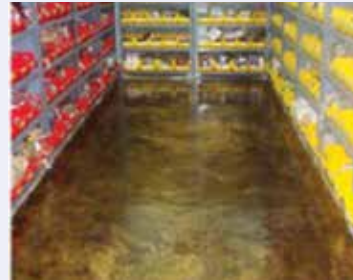
Fig. 21: Floor of Hoovers spares-blast proof machine room before

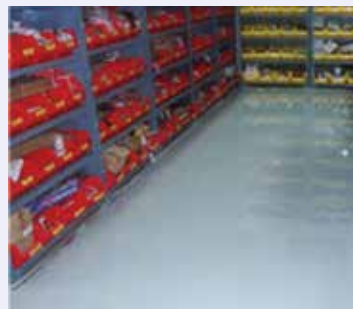
Fig. 22: Floor of Hoovers spares-blast proof machine room after self levelling flooring

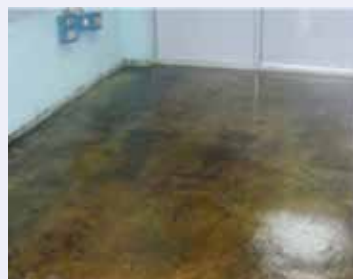
Fig. 23: Floor of TSS Confidential room before

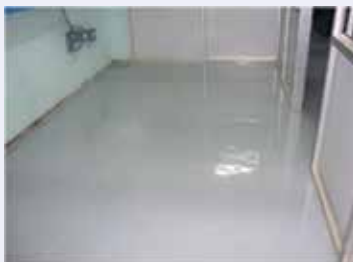
Fig. 24: Floor of TSS Confidential room after self levelling flooring

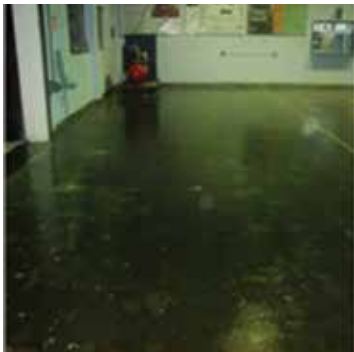
Fig. 25: Workshop Master Bay Before

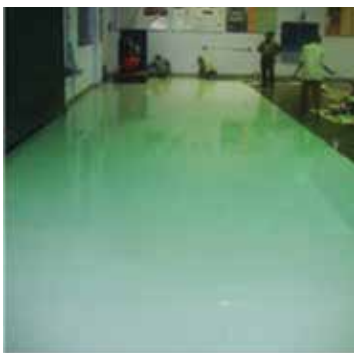
Fig. 26: Workshop Master Bay after self levelling flooring

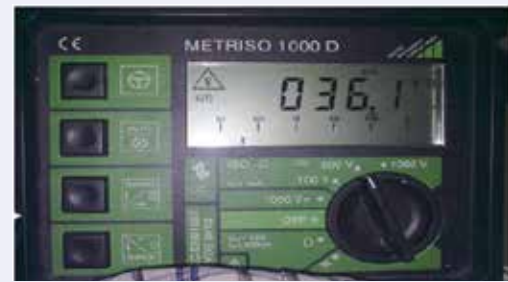
Resistance meter: It should be calibrated to determine the resistance R of the floor covering to an accuracy of $\pm 5\%$ in the range of $10^3 \Omega$ to $10^{10} \Omega$ and an accuracy of $\pm 10\%$ greater than $10^{10} \Omega$. For resistance less than $10^6 \Omega$ it should be 500 volts D.C. The resistance meter used in this test is shown in Fig. 27.

Fig. 27: Resistance meter

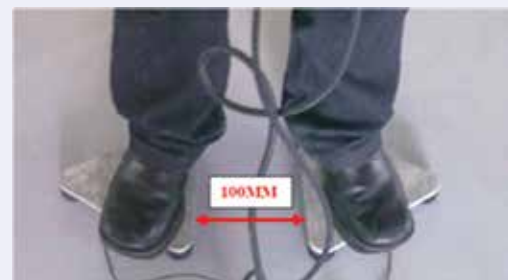
Two cleaned tripod electrodes were placed, separated by a distance of 100 mm, on the surface of the dry floor covering. Each of the electrodes was pressed to apply a load of minimum 300 N on the floor covering. This was achieved by using a person's body weight standing on foot on each electrode as shown in Fig. 28.

Fig. 28: Checking antistatic property of self-levelling epoxy flooring

The resistance was measured by a Digital Megger after 10 s to 15 s of switching on of the equipment. The procedure was repeated 15 times after shifting the tripod electrodes. The testing was carried out as per standard procedures given in EN 1081 and test results were found out to be within ranges and the anti-static property of the same flooring could be checked and verified.
